MONTHLY NEWSLETTER OF THE PALOS VERDES AMATEUR RADIO CLUB

SEPTEMBER 2018

Astron Linear DC Power Supplies (continued)

Part 2: Troubleshooting and repair example, RS-12A

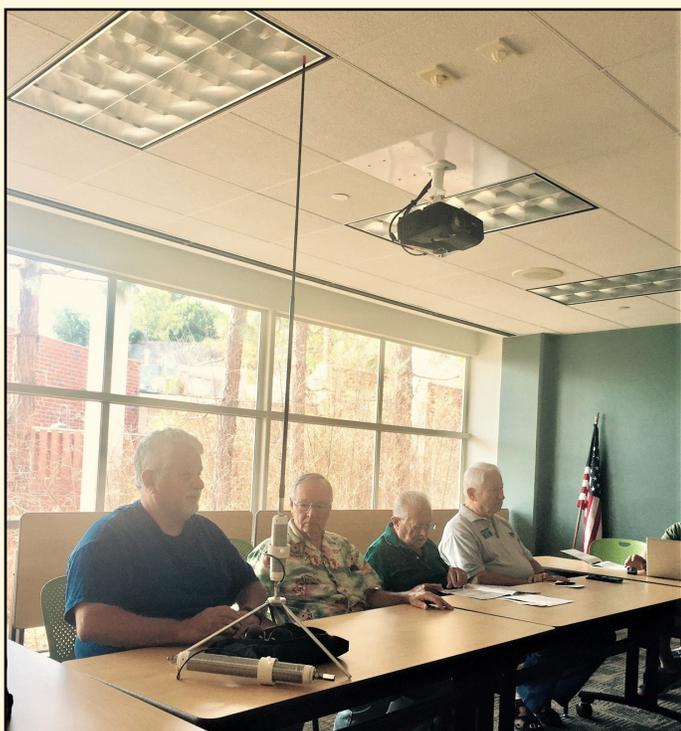
Above: Jerry, NG6R, showed his resonance shifter box enabling an 80-meter antenna cut for the phone sub-band to also serve the CW sub-band.

At the PVARC's August 11th HF Enthusiasts meeting among the impressive new devices shown was the Jerry Kendrick NG6R resonance shifter extensively described in the previous **QRO** issue. This shifter alleviates a problem noted at Field Day when the same antenna is needed for different parts of the 80-meter band for CW and SSB (voice), though initially resonant for only one of the two frequency areas.

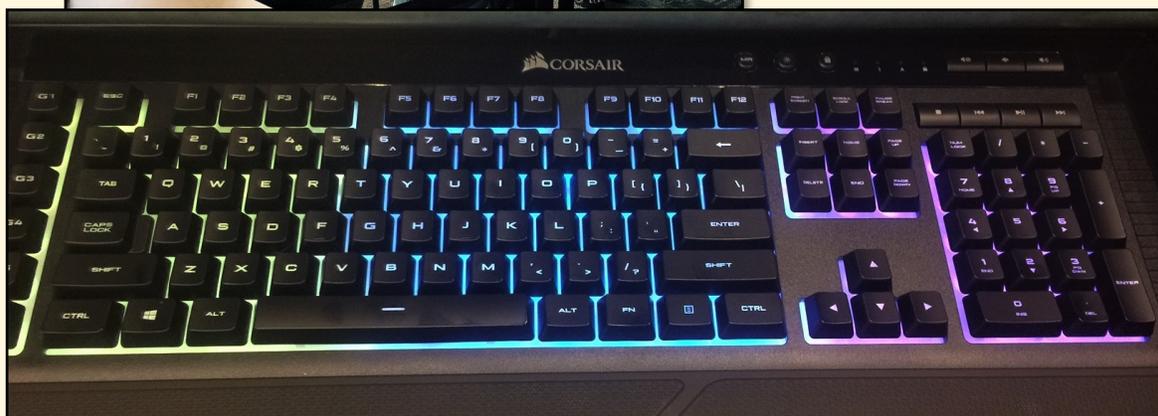
Upper Left: George, WA6YBR, showed his compact 80-40 meter tabletop antenna.

George Nestojko WA6YBR showed us his small HF "tabletop" antenna, the 40M and 80M coils being purchased, and the tripod base home-brewed by George (see photo). Jeff Wolf K6JW told about his new Corsair gaming computer keyboard, which has built-in illumination to improve visibility at night (and for some of us, in the daytime!). Two attendees, Carlos Lemmi WD6Y and Malin Dollinger KO6MD (photo), immediately acquired one for themselves.

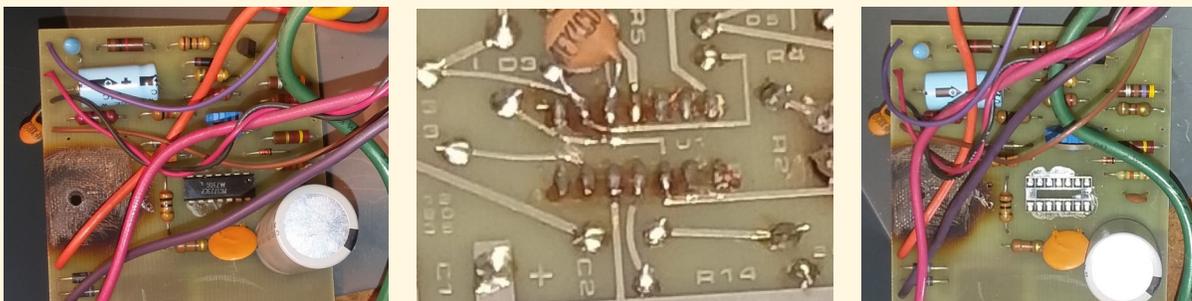
Figure 1. (left) Voltage regulator board with 14-pin LM723 integrated circuit shown prior to its removal; (middle) Solder side of IC prior to solder removal using flux-infused copper braid wicking technique; (right) Component side of board after installing IC socket for ease in replacing IC should it fail in the future. Note in left and right panels an area of PCB discoloration from overheating of (now removed) TIP29 driver transistor and heat sink. PHOTOS: JERRY KENDRICK, NG6R

Unlike most Astron power supplies, this older unit had the 14-pin LM723 IC soldered directly onto the regulator board, instead of being plugged into a socket. (That saved cost for the manufacturer, but it's a nuisance for the repair technician to remove and replace this device.) Of the two options—solder in a replacement IC or install a 14-pin socket for replacement ease in the future—we selected the latter approach. Figure 1 (below) shows before and after photos. Solder around each of the 14 pins was “wicked” away using flux-infused copper braid, the old IC was removed, and the solder-through holes were cleaned out prior to soldering in the new socket for the replacement LM723 IC.

While inspecting the voltage regulator board, it was noticed that there had been significant heating around and under the TIP29 driver transistor heat sink (shown on the left side of the board in the first and third panels of Figure 1). At the time that the IC was replaced, it seemed prudent to simply replace this previously overheated driver transistor as well. A batch of ten new Texas Instruments TIP29 devices had been received and one was soldered into place and secured to the board, along with the cleaned up heat sink, using an appropriate amount of silicone heat transfer compound.

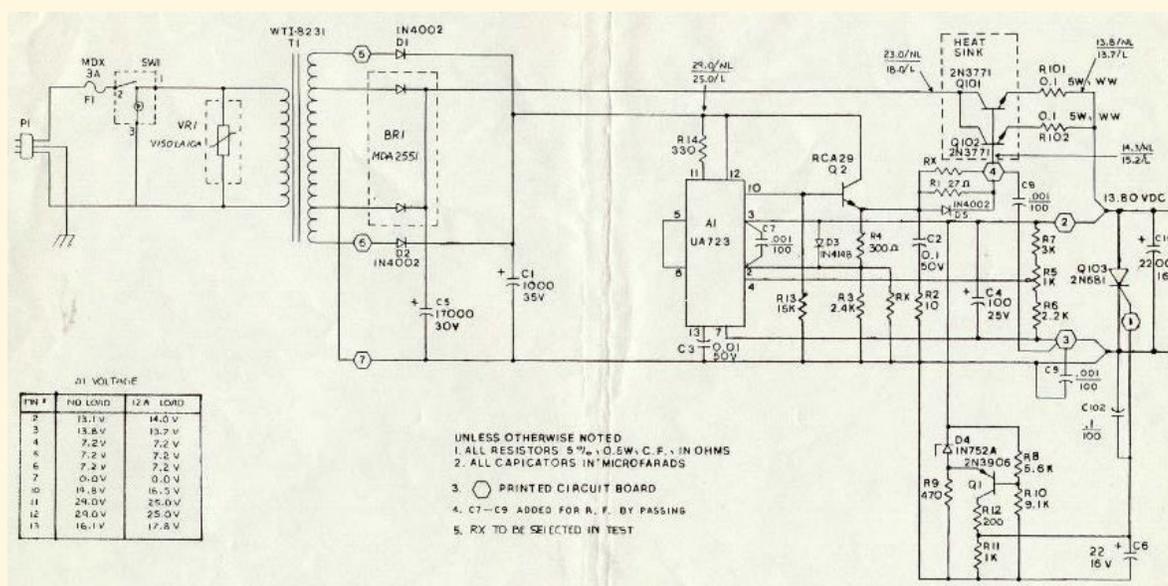
Figure 2. Schematic of Astron RS-12A power supply. Note location and configuration of the active devices discussed in this paper: LM723 IC (labeled UA723 here); Q1 2N3906 over-voltage protection device; Q2 RCA29 (TIP29) driver transistor; Q101 and Q102 2N3771 pass (power) transistors; and, Q103 SCR

The over-voltage protection circuit is centered on Q1 (2N3906), shown in the lower right portion of the schematic in Figure 2, and uses a thyristor or silicon controlled rectifier (SCR) [Q103 in the schematic] directly across the output terminals of the PS. The concept is that the Q1 circuit samples the output voltage and if it determines that the voltage is too high, it will send a command voltage to turn on the SCR and effectively and non-destructively short the output terminals.

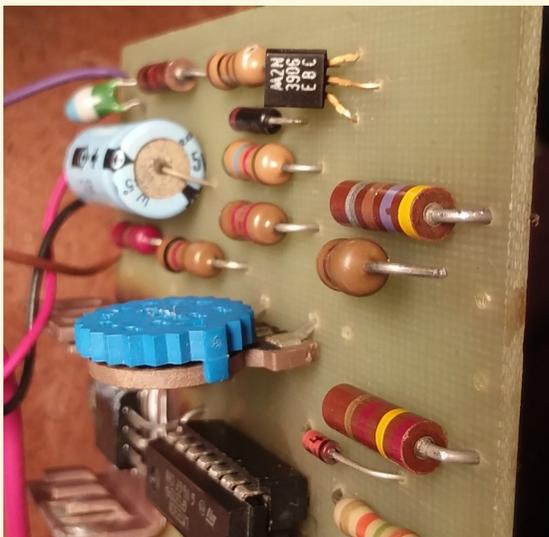
Figure 3. Close-up of Q1 2N3906 over-voltage protection circuit showing one of two base bias resistors (middle right in the photo) that readily separated from the PCB upon gentle prying; it had not been securely soldered to the PCB but the disconnect was hidden inside the through hole; the part was subsequently re-soldered as part of the repair. Note at bottom of this photo the newly installed IC socket with a new LM723 plugged into it. PHOTO: JERRY KENDRICK, NG6R

Yet something in this circuit wasn't working properly. So, from the back side (or solder side) of the board, component values were again checked. But, this time one of the two resistors in the Q1 transistor base bias voltage divider appeared open. This was strange, as it had previously read OK when measured from the component side. A gentle prying tug on the resistor (without heating the solder connection) caused one end to come up out of the through hole and the end is shown in the middle right portion of Figure 3. From appearances, it had seemed well seated in the board as viewed from the component side. And the solder side showed a well-flowed and healthy appearance of the solder connection. However, in fact, one end of the resistor was not making good contact (out of sight inside the through hole) and was the source of non-operation of this protective circuit. After properly re-soldering the resistor and powering up the unit, a voltage of 0.9V was measured at the output of the power supply (and fortunately, the AC fuse did not blow). This was appropriate given the over-voltage readings made earlier and demonstrated that the over-voltage protective circuit was now working as it should. But, of course, the original over-voltage issue still existed and now had to be resolved.

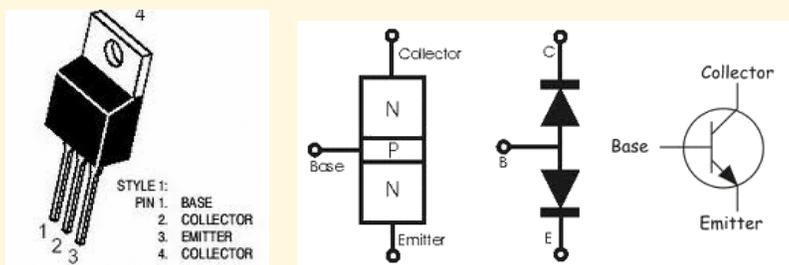
Figure 4. TIP29 driver transistor pinouts and conceptual representation as two diodes back to back; this concept can be exploited as a quick check to determine proper transistor operation; however, it's not 100% reliable as a test method, as discussed in the text below.

The new and just installed Q2 TIP29 transistor was removed and tested. Figure 4 shows the pinouts. As we know, an inexpensive ohmmeter (not a high-end digital multi-meter that has low voltage on its probes when acting as an ohmmeter) can be used to quickly test transistors, as illustrated in Figure 4.

The transistor's B-C junction and B-E junction (each behaving like diodes) measured exactly what they should, and in both directions as the VOM leads were reversed. This was expected, since the device was new. However, checking resistance from the emitter to the collector (which should read many megohms in both directions of the VOM leads) revealed that there was a several-hundred-ohms resistance measurement. This was totally unexpected and showed that this brand new device was actually defective; it had internal leakage between the emitter and collector that was not detectable in the usual B-E and B-C resistance quick checks. Another new TIP29 device from the batch of ten was installed (after checking it as much as possible on the bench), again with proper heat transfer compound applied when installing on the heat sink.

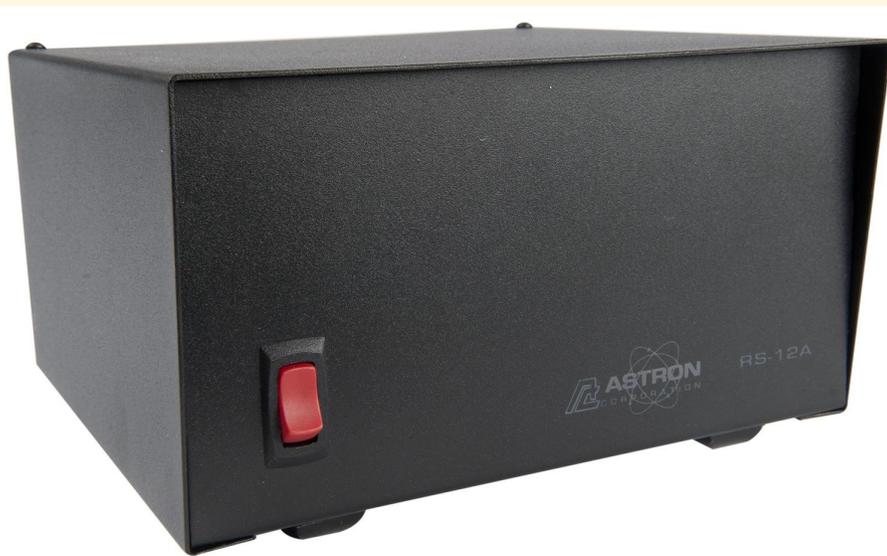
Left: The power supply discussed in this article...a fully-assembled new Astron 12A is a compact metal box with plain front panel (no meters.)
